## **Stagnation and freezing tests and drain back behavior for solar collector loop with SEIDO5-8 solar collector**

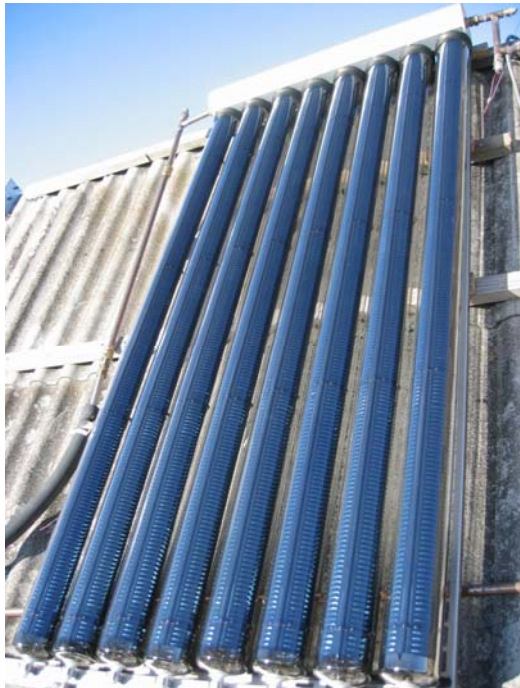
Figure 1. SEIDO5-8 on the roof of the lab at DTU

A drain back solar collector loop with a solar collector of 8 tubes, SEIDO5-8, was installed in the laboratory test facility for solar heating systems at DTU to investigate the long term influences of stagnation and freezing on the evacuated tubular solar collector and the behavior of start up and emptying for a drain back system, see figure 1 and 2.

The tests started on March 19, 2012, and ended at August 18, 2013. Stagnation occurred 11 days with a total duration of more than 343 hours. The collectors were in no way damaged in spite of the high number of stagnation periods with high temperatures. Further, the collectors were not damaged by the periods in the winter 2012-2013 with outdoor temperatures below 0°C. The tests show that SEIDO5-8 is suitable for drain back systems.

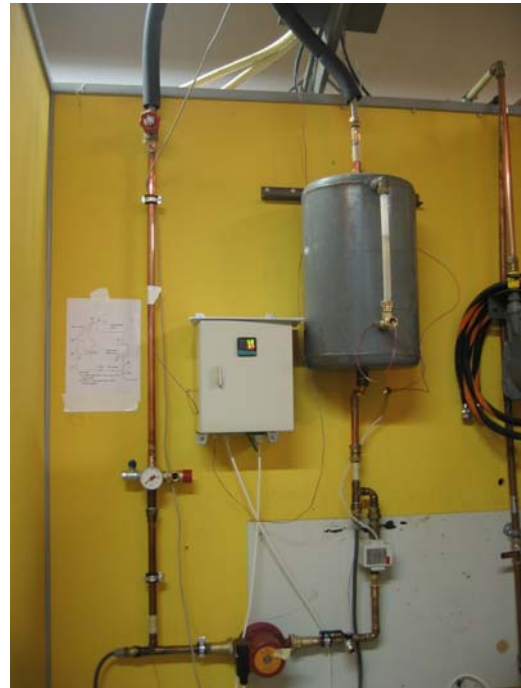
Figure 2. Drain back water tank in a solar collector loop

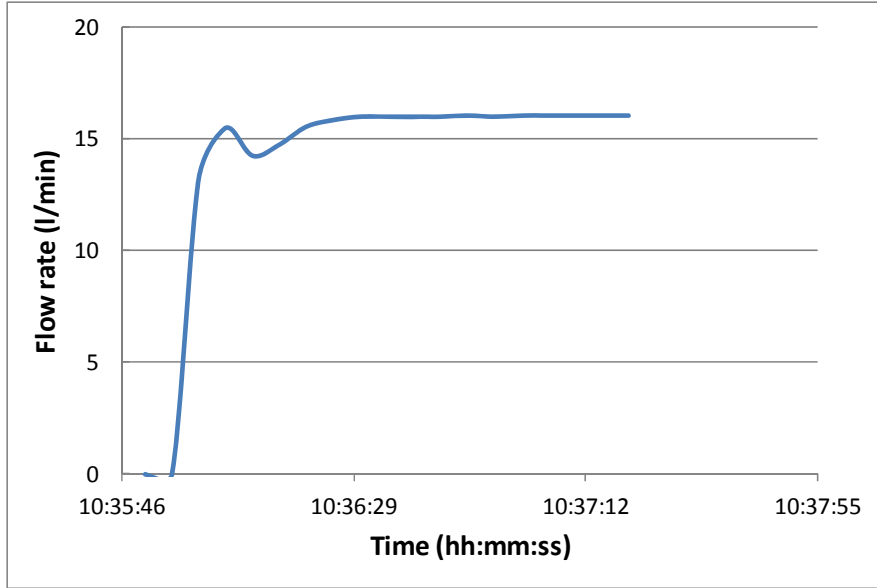
Figure 3. Volume flow rate during start up.

The behavior of start up for the solar collector loop for different flow rates are shown in figures 3, 4 and 5.

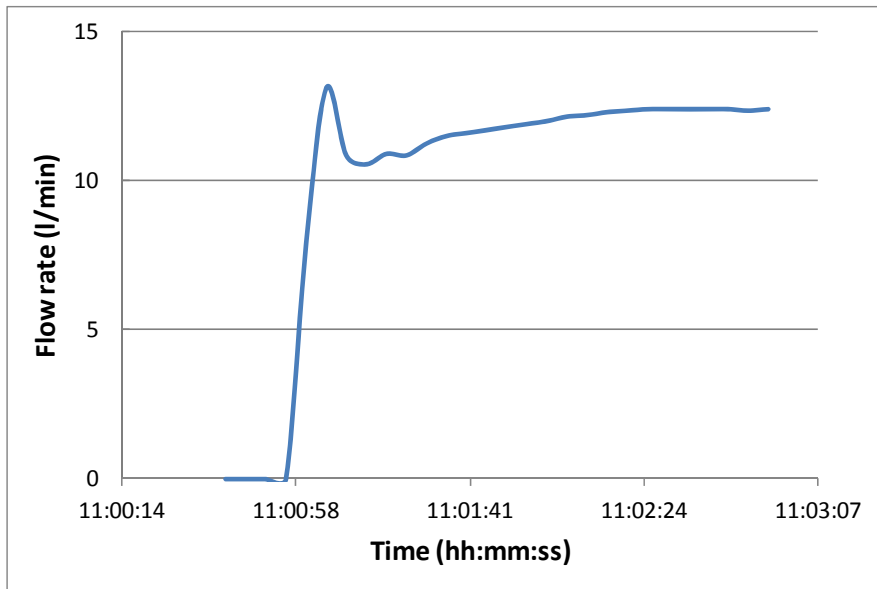
Figure 4. Volume flow rate during start up.

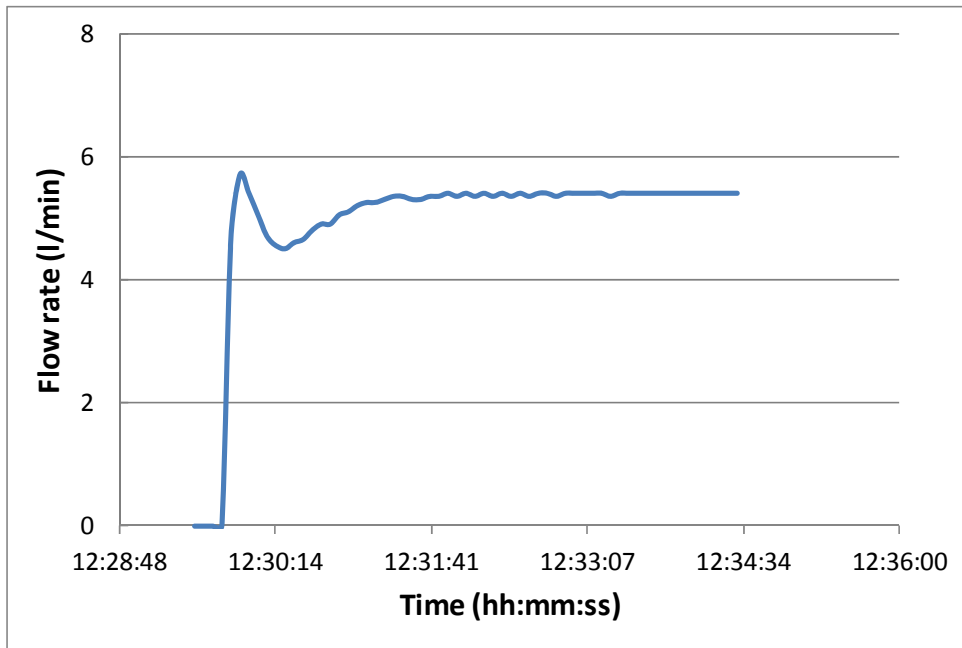
Figure 5. Volume flow rate during start up.

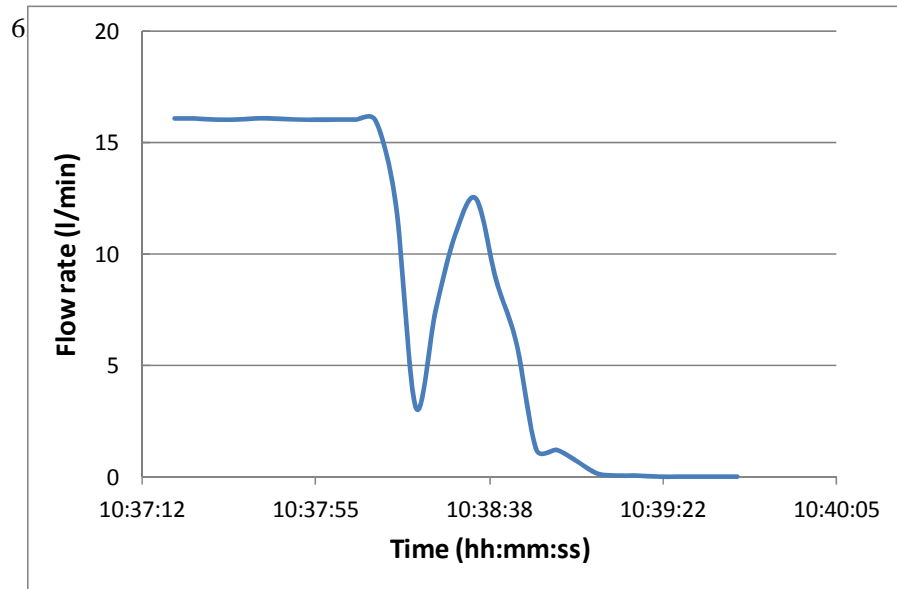
Figure 6. Volume flow rate after stop of pump.

The behavior of emptying for the solar collector loop for different volume flow rates are shown in figure

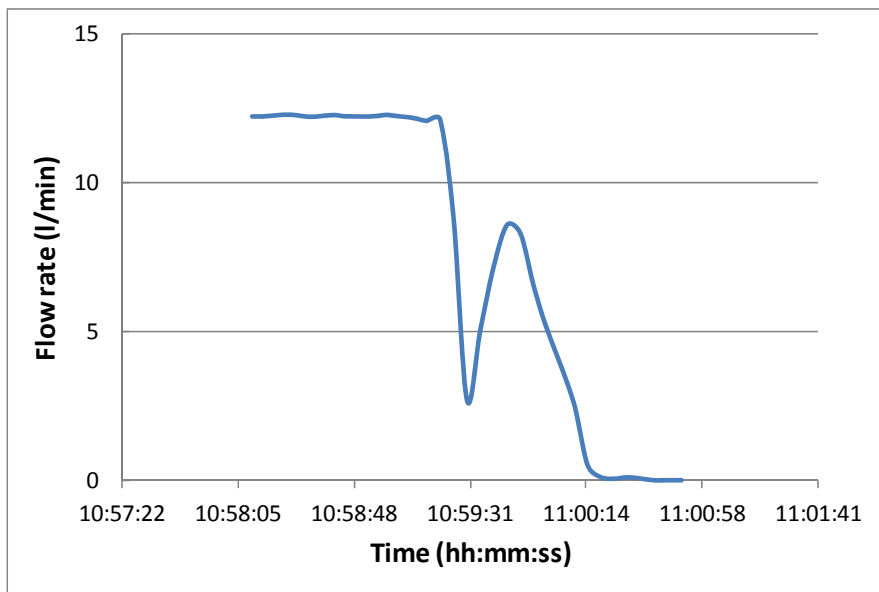
Figure 7. Volume flow rate after stop of pump.

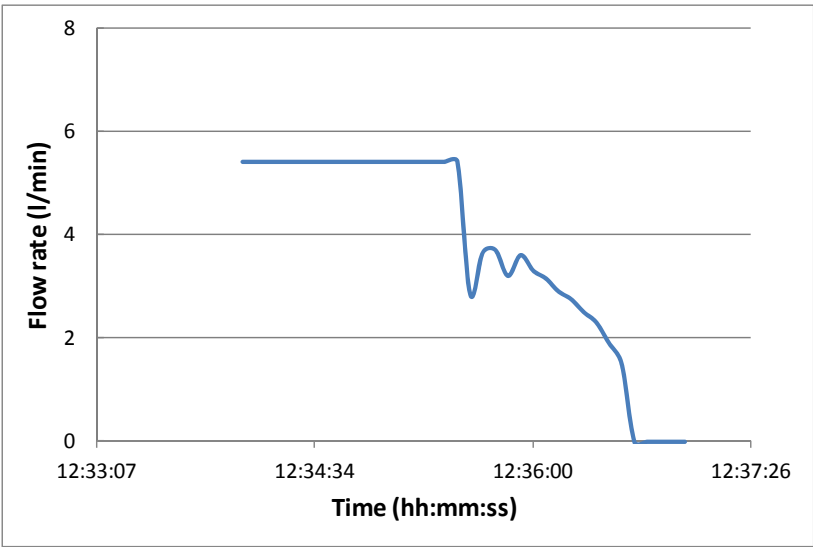
Figure 8. Volume flow rate after stop of pump.
